**Certificate of Conformance for Freight Container Mechanical Seal Testing**  
**Seal Classification: High Security Seal**

試驗報告 TEST REPORT

SUBJECT : Freight containers Mechanical seals classification Testing

Name of Article: TAVSEAL BP

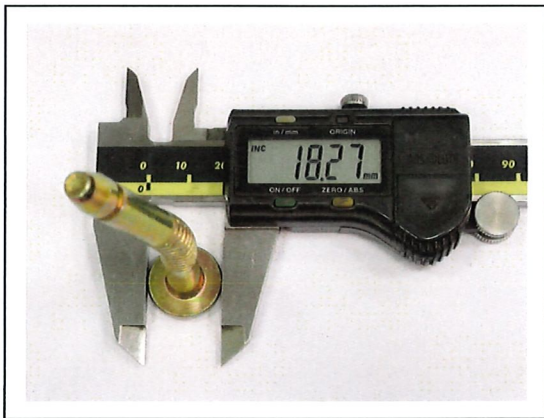
| Specimen No. | Measurement (mm) | | Pass/Fail |
|---|---|---|---|
| 26 | Pin Head | 18.27 | Pass |

The minimum diameter (or minimum widest cross-dimension) for the metal components of a bolt seal shall be 18 mm.

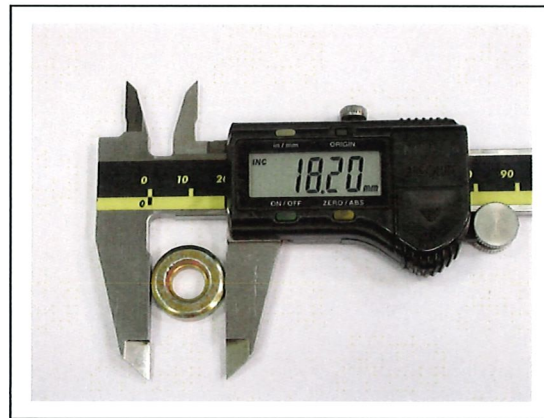
| Specimen No. | Measurement (mm) | | Pass/Fail |
|---|---|---|---|
| | Lock Body | 18.20 | Pass |

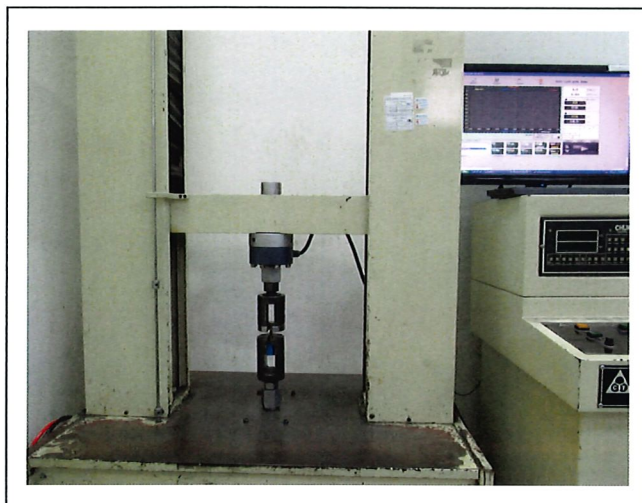
Universal Testing Machine

The seal was gripped in a tensile machine and a pull force applied.

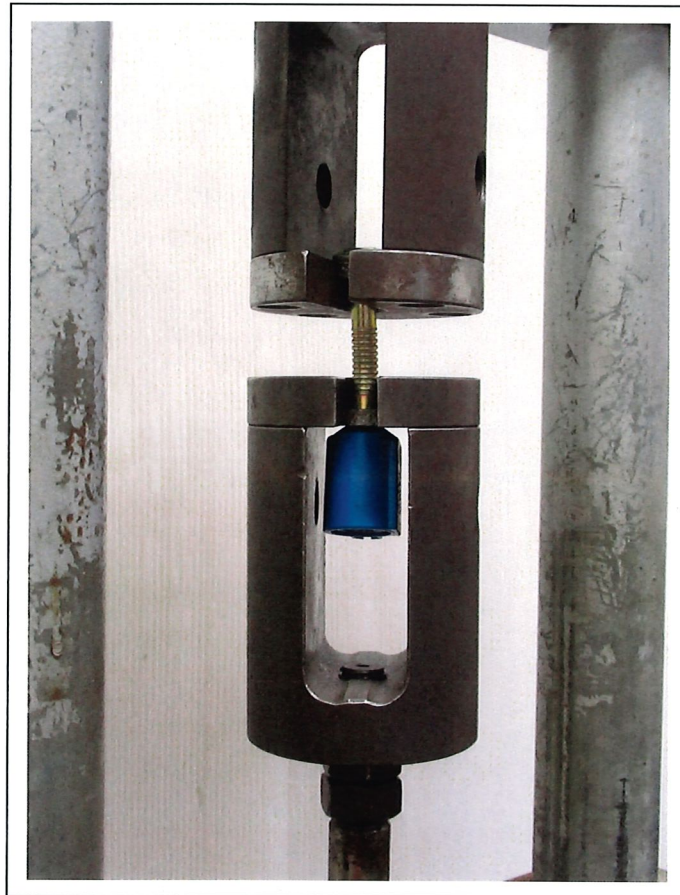
Impact Set up

The impact test is performed at 18 degrees C and minus 27 degrees C of temperature.

The impact load is applied at the locking mechanism of the seal in the direction opposite the direction used in locking the seal.
