**Certificate of Conformance for Freight Container Mechanical Seal Testing**  
**Seal Classification: High Security Seal**

Name of Article: TAVSEAL BP

Test Report No. : N0528172-T01

SUBJECT : Freight containers Mechanical seals classification Testing

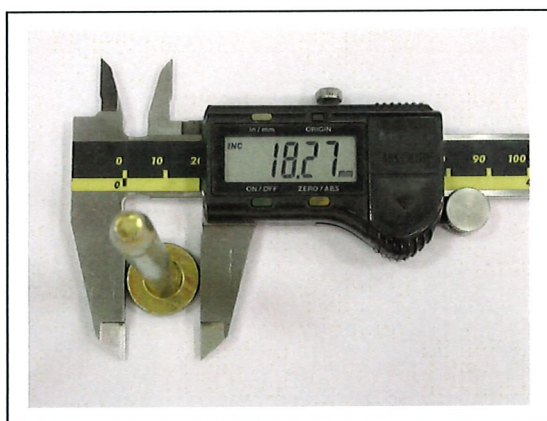
| Specimen No. | Measurement (mm) | | Pass/Fail |
|---|---|---|---|
| 26 | Pin Head | 18.27 | Pass |

The minimum diameter (or minimum widest cross-dimension) for the metal components of a bolt seal shall be 18 mm.

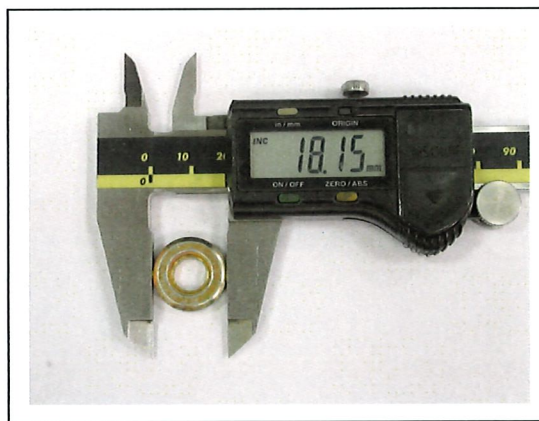
| Specimen No. | Measurement (mm) | | Pass/Fail |
|---|---|---|---|
| | Lock Body | 18.15 | Pass |

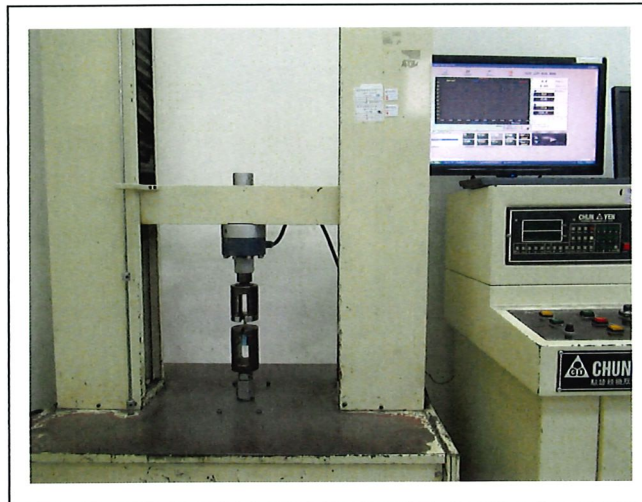
Tensile Set up

The seal was gripped in a tensile machine and a pull force applied.
