**Certificate of Conformance for Freight Container Mechanical Seal Testing**  
**Seal Classification: High Security Seal**

試驗報告 TEST REPORT

SUBJECT : Freight containers Mechanical seals classification Testing

Name of Article: TAVSEAL C25

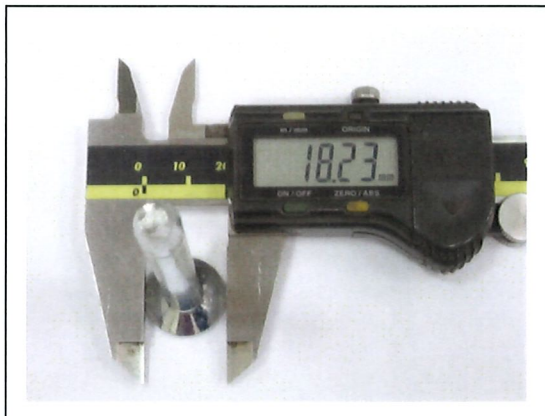
| Specimen No. | Measurement (mm) | | Pass/Fail |
|---|---|---|---|
| 26 | Pin Head | 18.23 | Pass |

The minimum diameter (or minimum widest cross-dimension) for the metal components of a bolt seal shall be 18 mm.

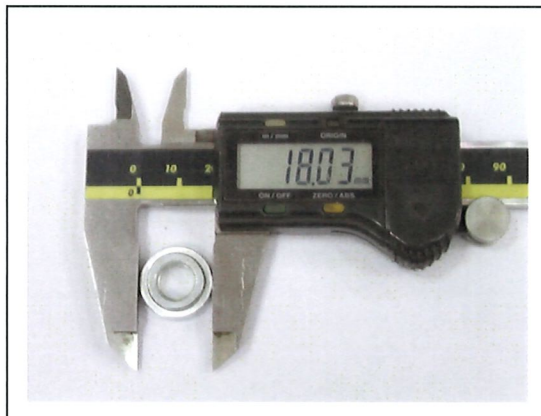
| Specimen No. | Measurement (mm) | | Pass/Fail |
|---|---|---|---|
| | Lock Body | 18.03 | Pass |

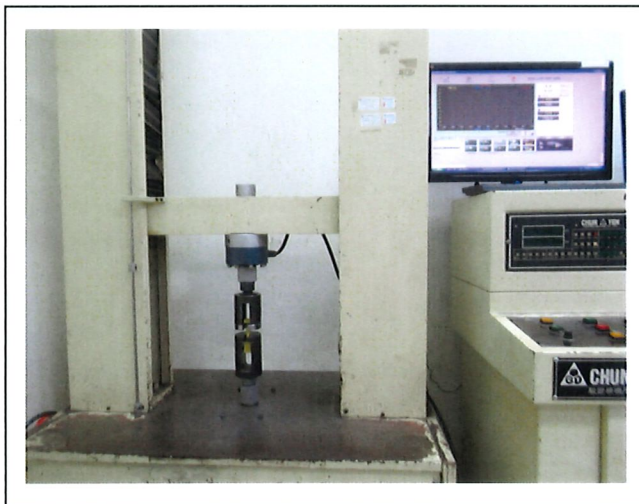
Testing Instrument : Universal Testing Machine (No.TG0103)

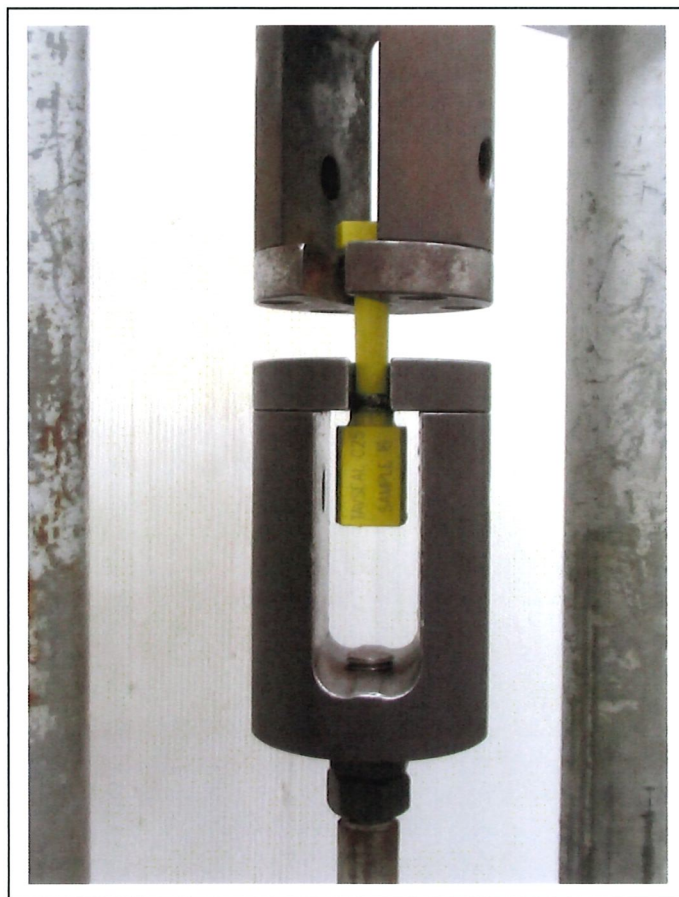
Impact Set up

The impact test is performed at 18 degrees Celsius and minus 27 degrees Celsius of temperature.  
The impact load is applied at the locking mechanism of the seal in the direction opposite the direction used in locking the seal.

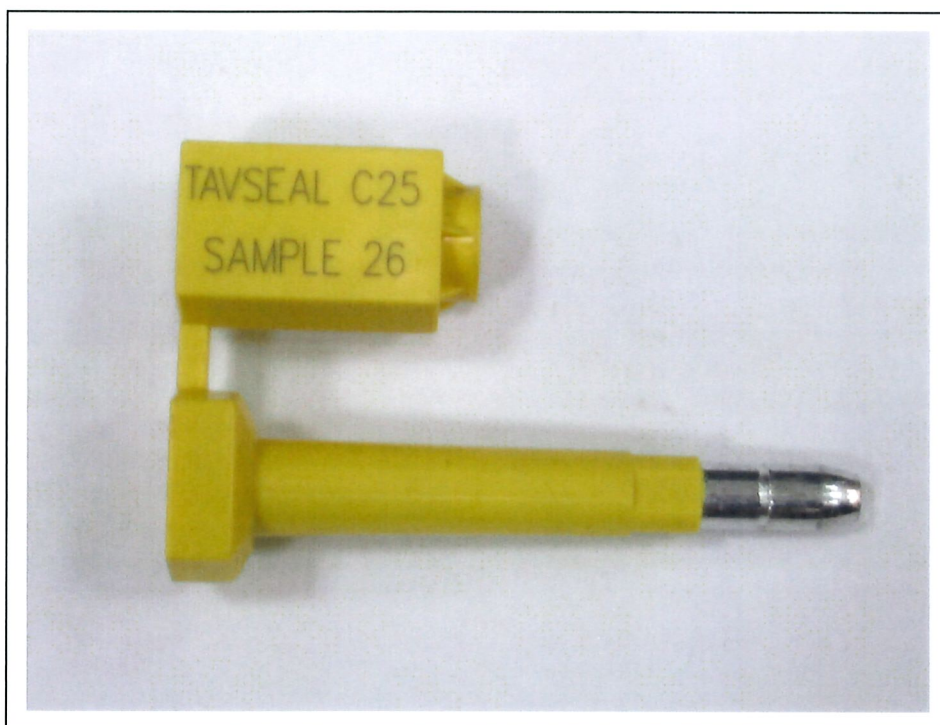
Name of Article : TAVSEAL C25

Type : BOLT SEAL
